[Docket No. 99-SW-80-AD; Amendment 39-12983; AD 2002-25-07]

Airworthiness Directives; Bell Helicopter Textron Canada Limited Model 206L, L-1, L-3, and L-4 Helicopters

2002-25-07 Bell Helicopter Textron Canada Limited: Amendment 39-12983. Docket No. 99-SW-80-AD. Supersedes AD 99-13-12, Amendment 39-11207, Docket No. 99-SW-23-AD.

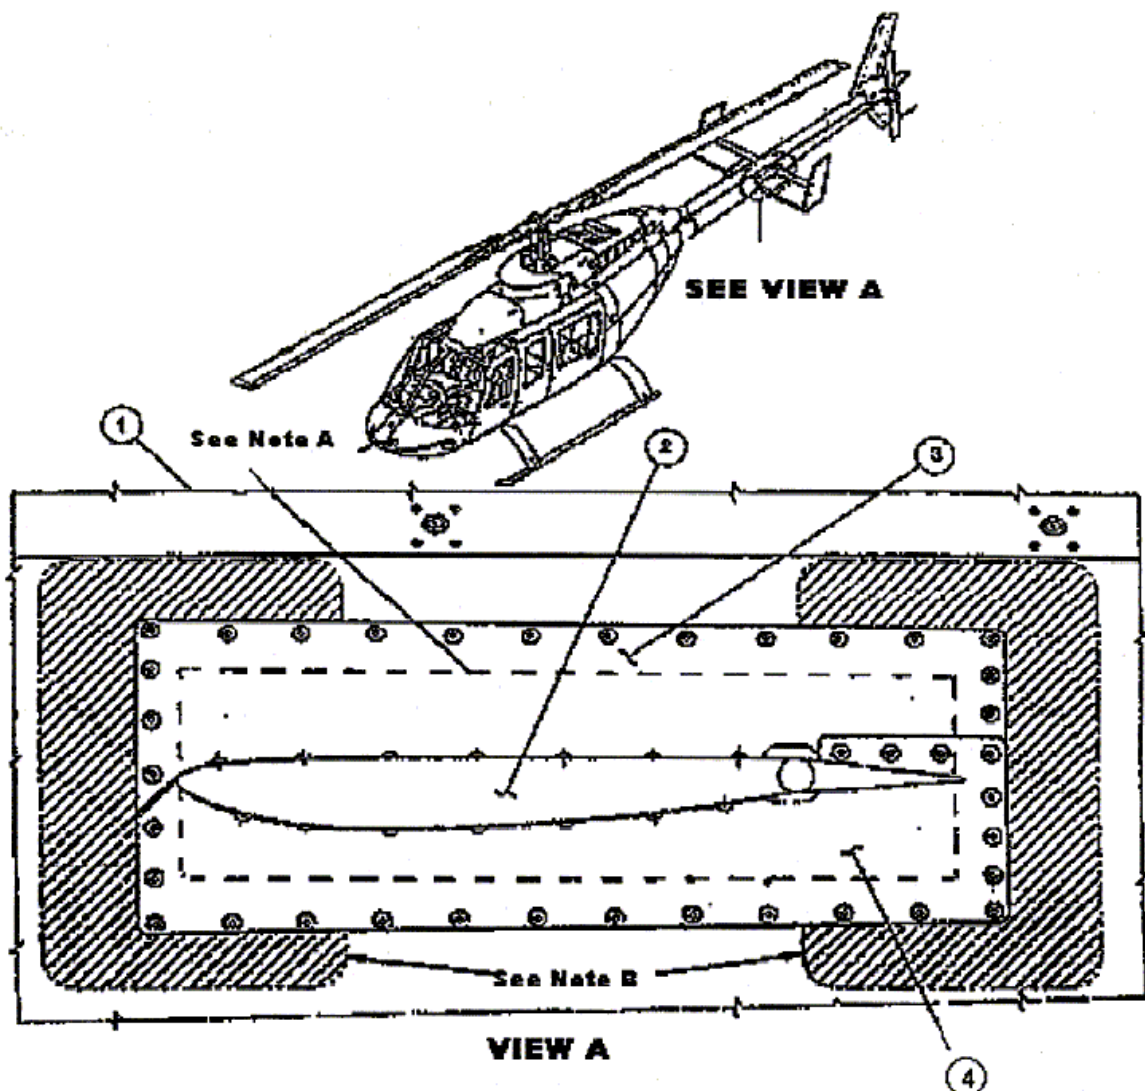
(a) Before further flight and thereafter at intervals not to exceed 10 hours time-in-service (TIS) until accomplishing a one-time fluorescent-penetrant inspection (FPI) required by paragraph (c)(2) of this AD, visually inspect for a crack in the tailboom using a 10-power or higher magnifying glass in the shaded areas as depicted in Figure 1 of this AD:

- A. Inspect entire edge of stabilizer opening on both sides of the tailboom.
- B. Inspect for a crack in these two areas on both sides of the tailboom

(b) At intervals not to exceed 5 hours TIS, visually check for a crack in the tailboom in the shaded areas as depicted in Figure 1 of this AD. The visual check may be performed by an owner/operator (pilot) holding at least a private pilot certificate and must be entered into the helicopter records showing compliance with this paragraph in accordance with 14 CFR 43.11 and 91.417(a)(2)(v).

(2) Perform a one-time FPI of the edges of the tailboom skins for any crack around the left and right horizontal stabilizer openings as shown in Figure 1 of this AD. Remove paint and primer to inspect the edges and exterior skin surface in the skin area at least $\frac{3}{4}$ inch around the edges of the horizontal stabilizer openings as shown in Figure 1 of this AD.

(2) Visually inspect the entire edge of the horizontal stabilizer opening on both sides of the tailboom for any crack using a 10-power or higher magnifying glass as shown in Figure 1 of this AD.

(g) If a crack is found during any check or inspection required by this AD, before further flight, replace the cracked tailboom with an airworthy tailboom modified according to the requirements of paragraph (e) of this AD or with an airworthy tailboom, P/N 206-033-004-181.
